**Flood Control Project Maintenance  
Levee Inspections**

**Fall 2009 Levee Maintenance Deficiency Summary Report**

**Sacramento River Basin**

**Reclamation District No. 0003 Grand Island**

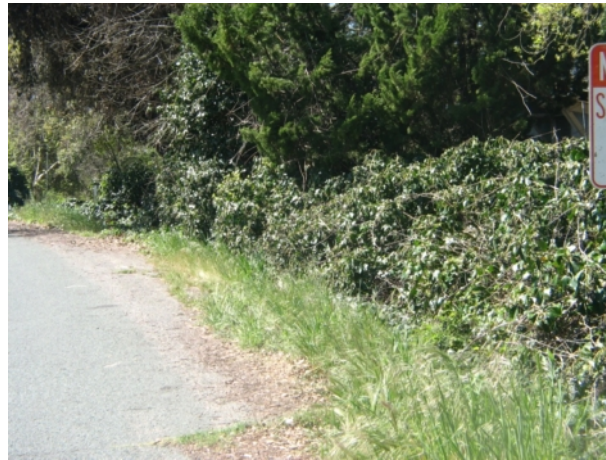
richard\_20091104\_1.jpg

Levee Mile Report Line	3
Start Levee Mile	0.22
End Levee Mile	0.33
Location	Water Side
Category	Earthen Levee
Item	Encroachments

Dense landscaping on waterside from LM 0.22 to 0.28

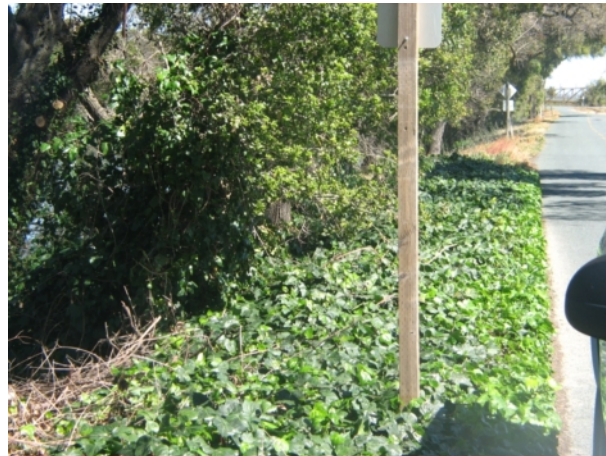
richard\_20091104\_2.jpg

Levee Mile Report Line	3
Start Levee Mile	0.22
End Levee Mile	0.33
Location	Water Side
Category	Earthen Levee
Item	Encroachments

Looking upstream at dense landscaping on waterside slope from LM 0.22 to 0.28

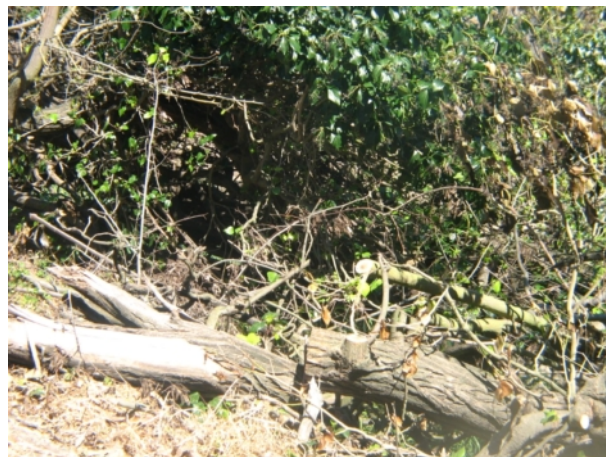
richard\_20091104\_4.jpg

Levee Mile Report Line	11
Start Levee Mile	1.08
End Levee Mile	1.09
Location	Land Side
Category	Earthen Levee
Item	Trim / Thin Trees

Down tree limbs on landside slope from LM 1.08 to 1.09

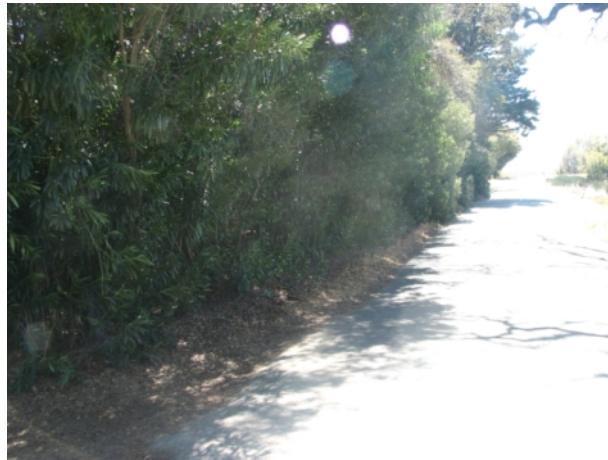
richard\_20091104\_5.jpg

Levee Mile Report Line	12
Start Levee Mile	1.21
End Levee Mile	1.27
Location	Land Side
Category	Earthen Levee
Item	Encroachments

Landscaping on landside slope block view of levee from LM 1.21 to 1.27

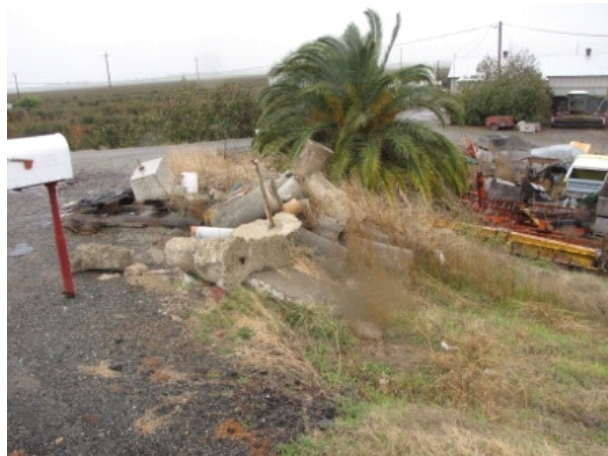
richard\_20091123\_119.jpg

Levee Mile Report Line	20
Start Levee Mile	2.11
End Levee Mile	2.11
Location	Land Side
Category	Earthen Levee
Item	Encroachments

Looking northeast at concrete rubble at landside shoulder and ramp.

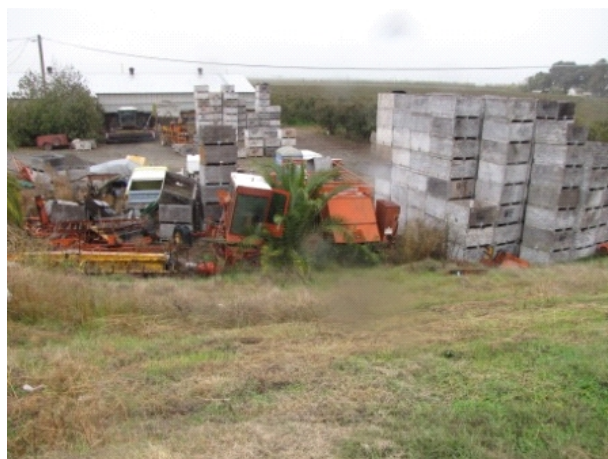
richard\_20091123\_120.jpg

Levee Mile Report Line	20
Start Levee Mile	2.11
End Levee Mile	2.11
Location	Land Side
Category	Earthen Levee
Item	Encroachments

Looking north at equipment and storage containers at landside toe.

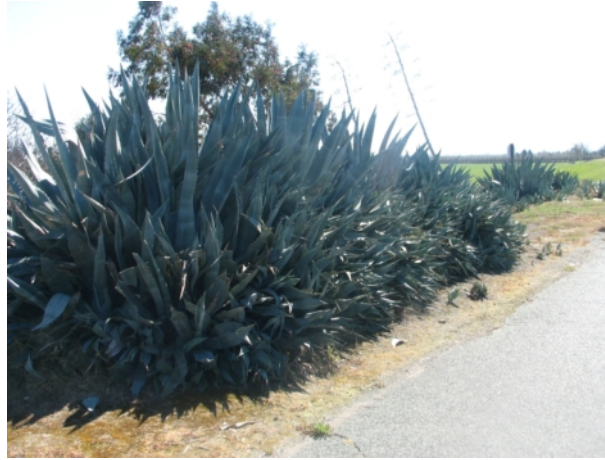
richard\_20091104\_6.jpg

Levee Mile Report Line	32
Start Levee Mile	7.08
End Levee Mile	7.10
Location	Land Side
Category	Earthen Levee
Item	Encroachments

Large Cactus plant on landside shoulder block view of levee slope from LM 7.08 to 7.10

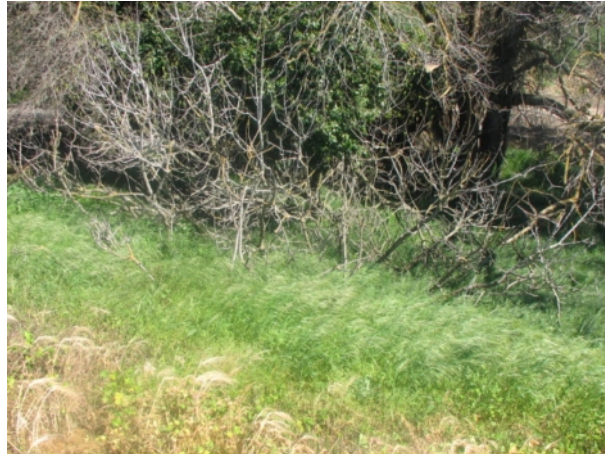
richard\_20091104\_12.jpg

Levee Mile Report Line	33
Start Levee Mile	7.81
End Levee Mile	7.83
Location	Water Side
Category	Earthen Levee
Item	Encroachments

Front view of dense trees at landside toe.

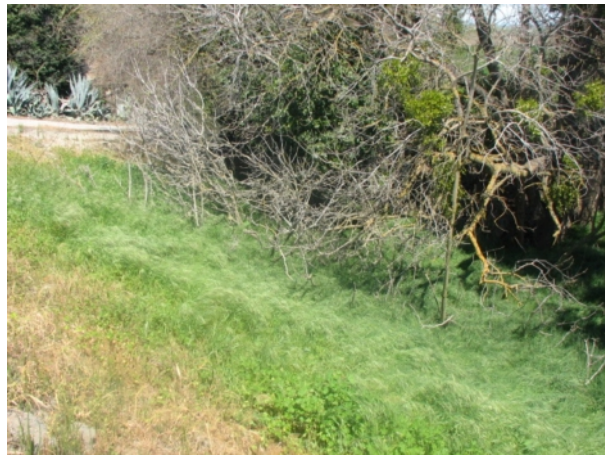
richard\_20091104\_13.jpg

Levee Mile Report Line	33
Start Levee Mile	7.81
End Levee Mile	7.83
Location	Water Side
Category	Earthen Levee
Item	Encroachments

Side view of dense trees at landside toe.

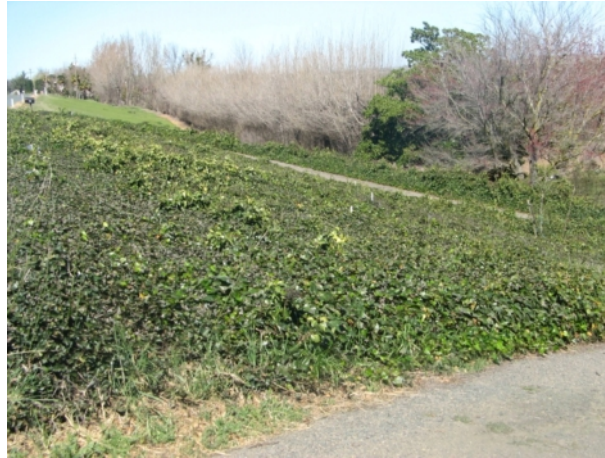
richard\_20091104\_7.jpg

Levee Mile Report Line	34
Start Levee Mile	7.95
End Levee Mile	8.00
Location	Land Side
Category	Earthen Levee
Item	Encroachments

Landscaping (Ivy) on landside slope blocking view of levee from LM 7.95 to 8.00

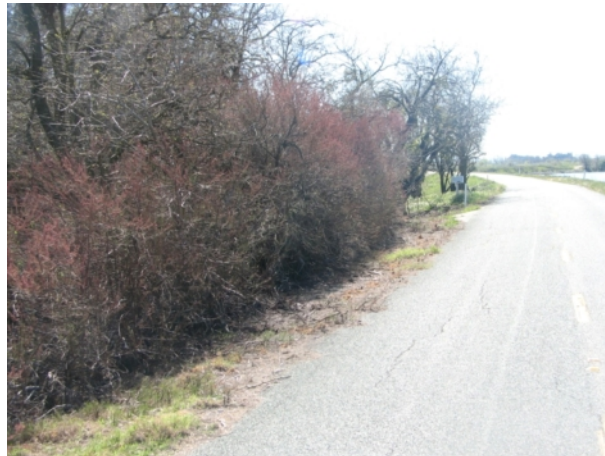
richard\_20091104\_8.jpg

Levee Mile Report Line	38
Start Levee Mile	10.20
End Levee Mile	10.22
Location	Land Side
Category	Earthen Levee
Item	Trim / Thin Trees

Trees to be trimmed on landside shoulder from LM 10.20 to 10.22

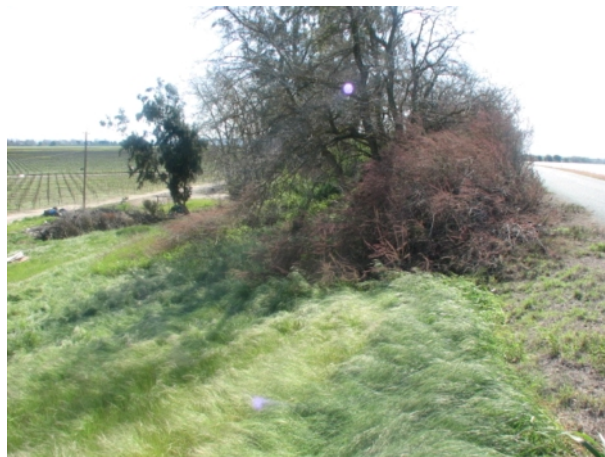
richard\_20091104\_9.jpg

Levee Mile Report Line	38
Start Levee Mile	10.20
End Levee Mile	10.22
Location	Land Side
Category	Earthen Levee
Item	Trim / Thin Trees

Side view of trees on landside shoulder.

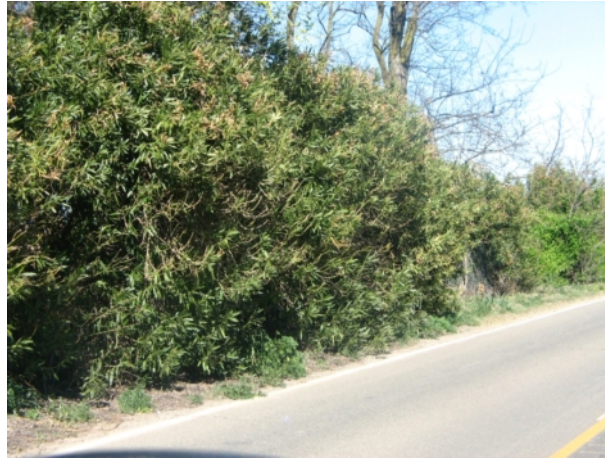
richard\_20091104\_15.jpg

Levee Mile Report Line	18
Start Levee Mile	5.94
End Levee Mile	6.00
Location	Land Side
Category	Earthen Levee
Item	Encroachments

Oleander on landside shoulder blocking view of levee slope from LM 5.94 to 6.00

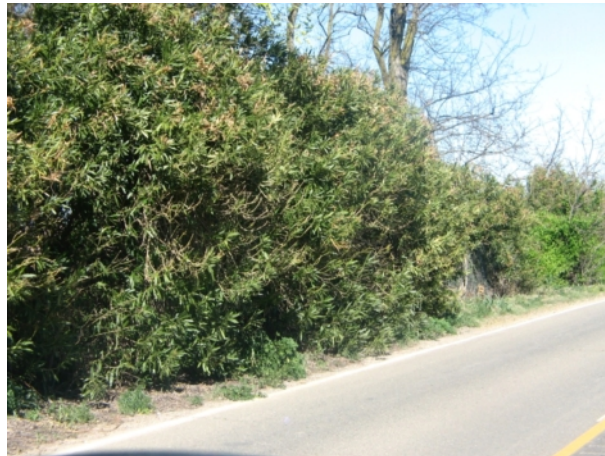
richard\_20091104\_16.jpg

Levee Mile Report Line	18
Start Levee Mile	5.94
End Levee Mile	6.00
Location	Land Side
Category	Earthen Levee
Item	Encroachments

Oleander on landside shoulder blocking view of levee slope from LM 5.94 to 6.00

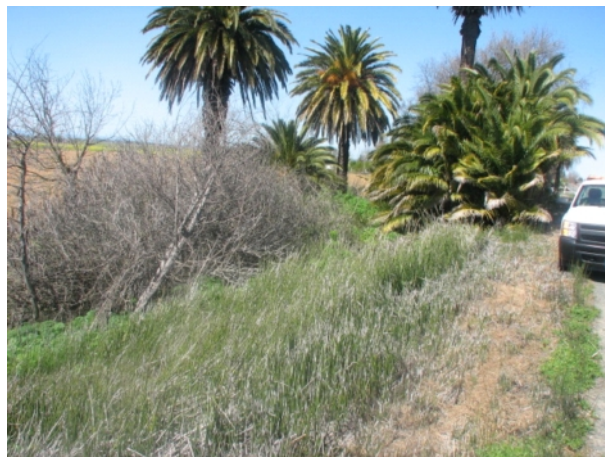
richard\_20091104\_17.jpg

Levee Mile Report Line	21
Start Levee Mile	7.02
End Levee Mile	7.04
Location	Land Side
Category	Earthen Levee
Item	Trim / Thin Trees

Dense trees at landside toe and shoulder

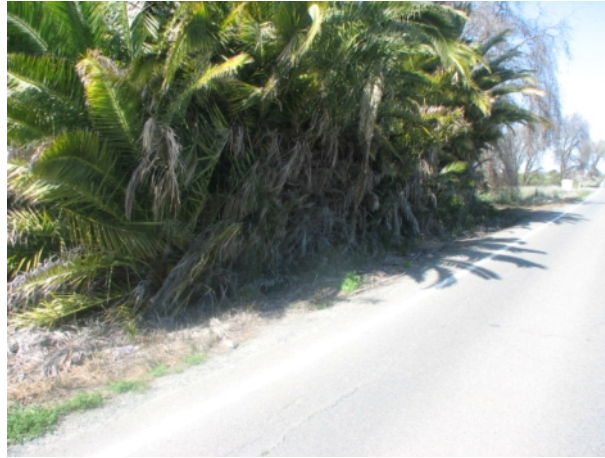
richard\_20091104\_18.jpg

Levee Mile Report Line	21
Start Levee Mile	7.02
End Levee Mile	7.04
Location	Land Side
Category	Earthen Levee
Item	Trim / Thin Trees

Front view of palm trees on landside shouldr

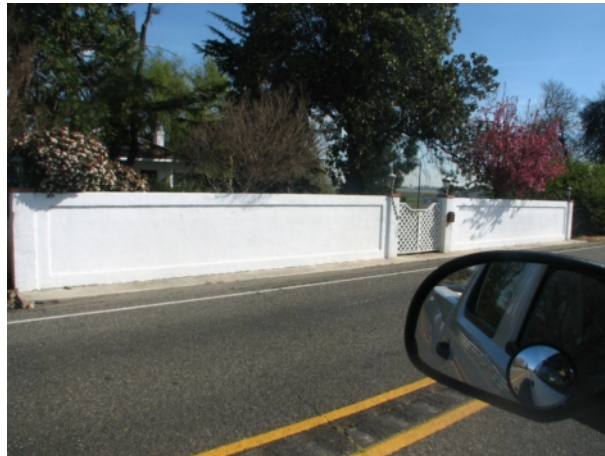
richard\_20091104\_19.jpg

Levee Mile Report Line	29
Start Levee Mile	10.13
End Levee Mile	10.13
Location	Land Side
Category	Earthen Levee
Item	Encroachments

Block/Concrete fence on landside shoulder at LM 10.13

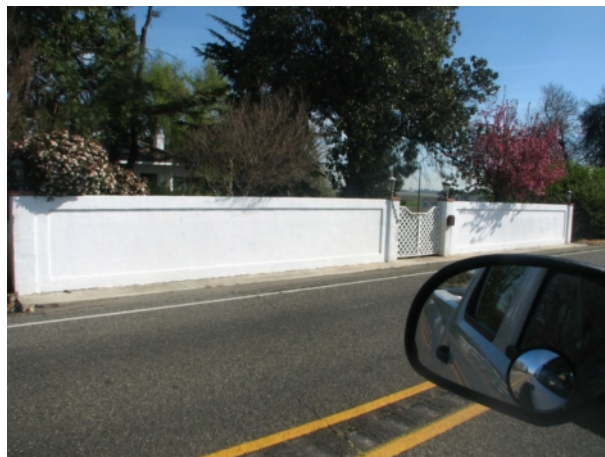
richard\_20091104\_20.jpg

Levee Mile Report Line	29
Start Levee Mile	10.13
End Levee Mile	10.13
Location	Land Side
Category	Earthen Levee
Item	Encroachments

Block/Concrete fence on landside shoulder at LM 10.13
